Scripta Metallurgica et Materialia, Vol. 33, No. 2, pp. 245-250, 1995
Copyright © 1995 Elsevier Science Ltd
Printed in the USA. All rights reserved
0956-716X/95 \$9.50 + .00

HYDROGEN ENHANCED THERMAL FATIGUE OF γ -TITANIUM ALUMINIDE

William Dunfee, Ming Gao, Robert P. Wei and William Wei*

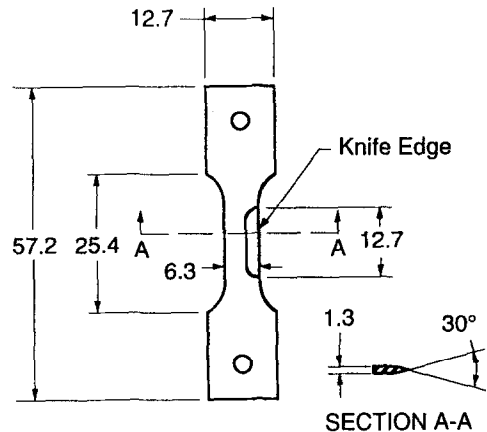
Dimensions in millimeters

Figure 2. A sketch of the specimen used for thermal cycling.

specimen design accounts for special environmental, thermal, and stress considerations. The specimens were thin and flat, with a 1.3 mm thick by 6.3 mm wide by 12.7 mm long gage length, Fig. 2. This geometry provides a high surface area-to-volume ratio to maximize the environmental exposure area for reaction, allows for rapid forced convective cooling, and ensures a uniform temperature distribution throughout the sample thickness. The specimen also has a sharp, wedge-shaped edge on one side to improve rapid cooling from a chilled gas jet, Fig. 2.
